NASA TN D-4916

POSTFLIGHT OPTICAL EVALUATION OF
THE RIGHT-HAND AND LEFT-HAND WINDOWS
OF GEMINI MISSIONS IV, V, VI, AND VII

*Manned Spacecraft Center
Houston, Texas*

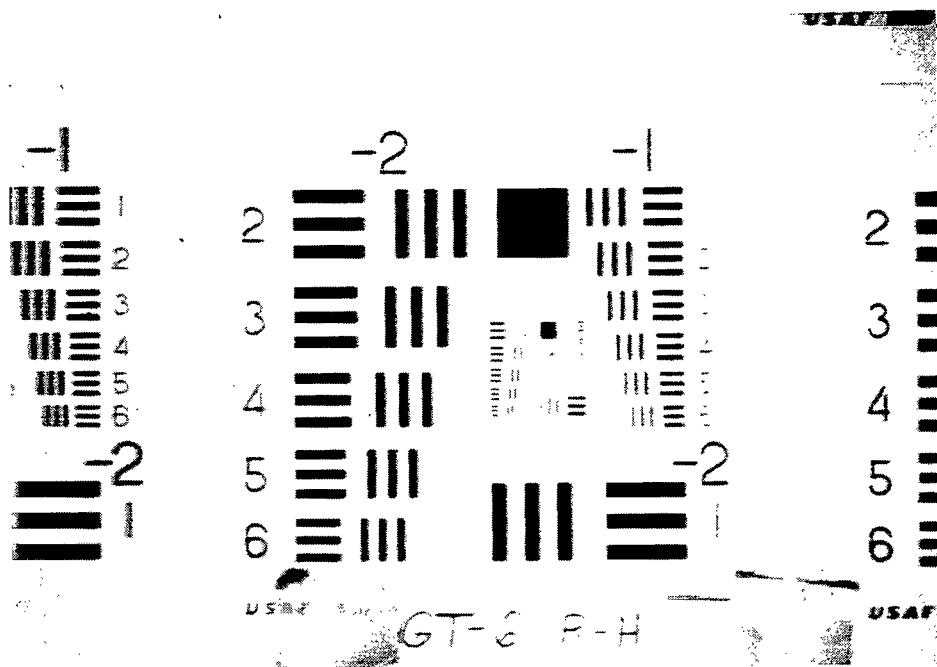
(a) Through dirty right window.

(b) Through clean right window.

Figure 13. - Photographs of USAF bar charts, G-VI.

(c) Through dirty left window.

(d) Through clean left window.

Resolution. - The NBS resolution chart (fig. 10(a)), and the USAF bar chart (fig. 10(b)) were taken with the telescope serving as a lens for the 35-mm camera. The charts, viewed through the dirty right windows, are shown in figures 11(a), 12(a), 13(a), and 14(a). The charts viewed through the clean right windows are shown in figures 11(b), 12(b), 13(b), and 14(b). The resolution charts (figs. 11(c), 12(c), 13(c), and 14(c)) were taken through the dirty left windows. The charts, viewed through the clean left windows, are shown in figures 11(d), 12(d), 13(d), and 14(d). Results of the resolution studies are presented in table VI. The table gives both the percent loss in resolution through the dirty and clean windows and the percent degradation due to the contamination.
